**Decision Document for
No Further Response Action Planned**

**Bullen Point Radar Installation,
Alaska**

24 MAY 1996

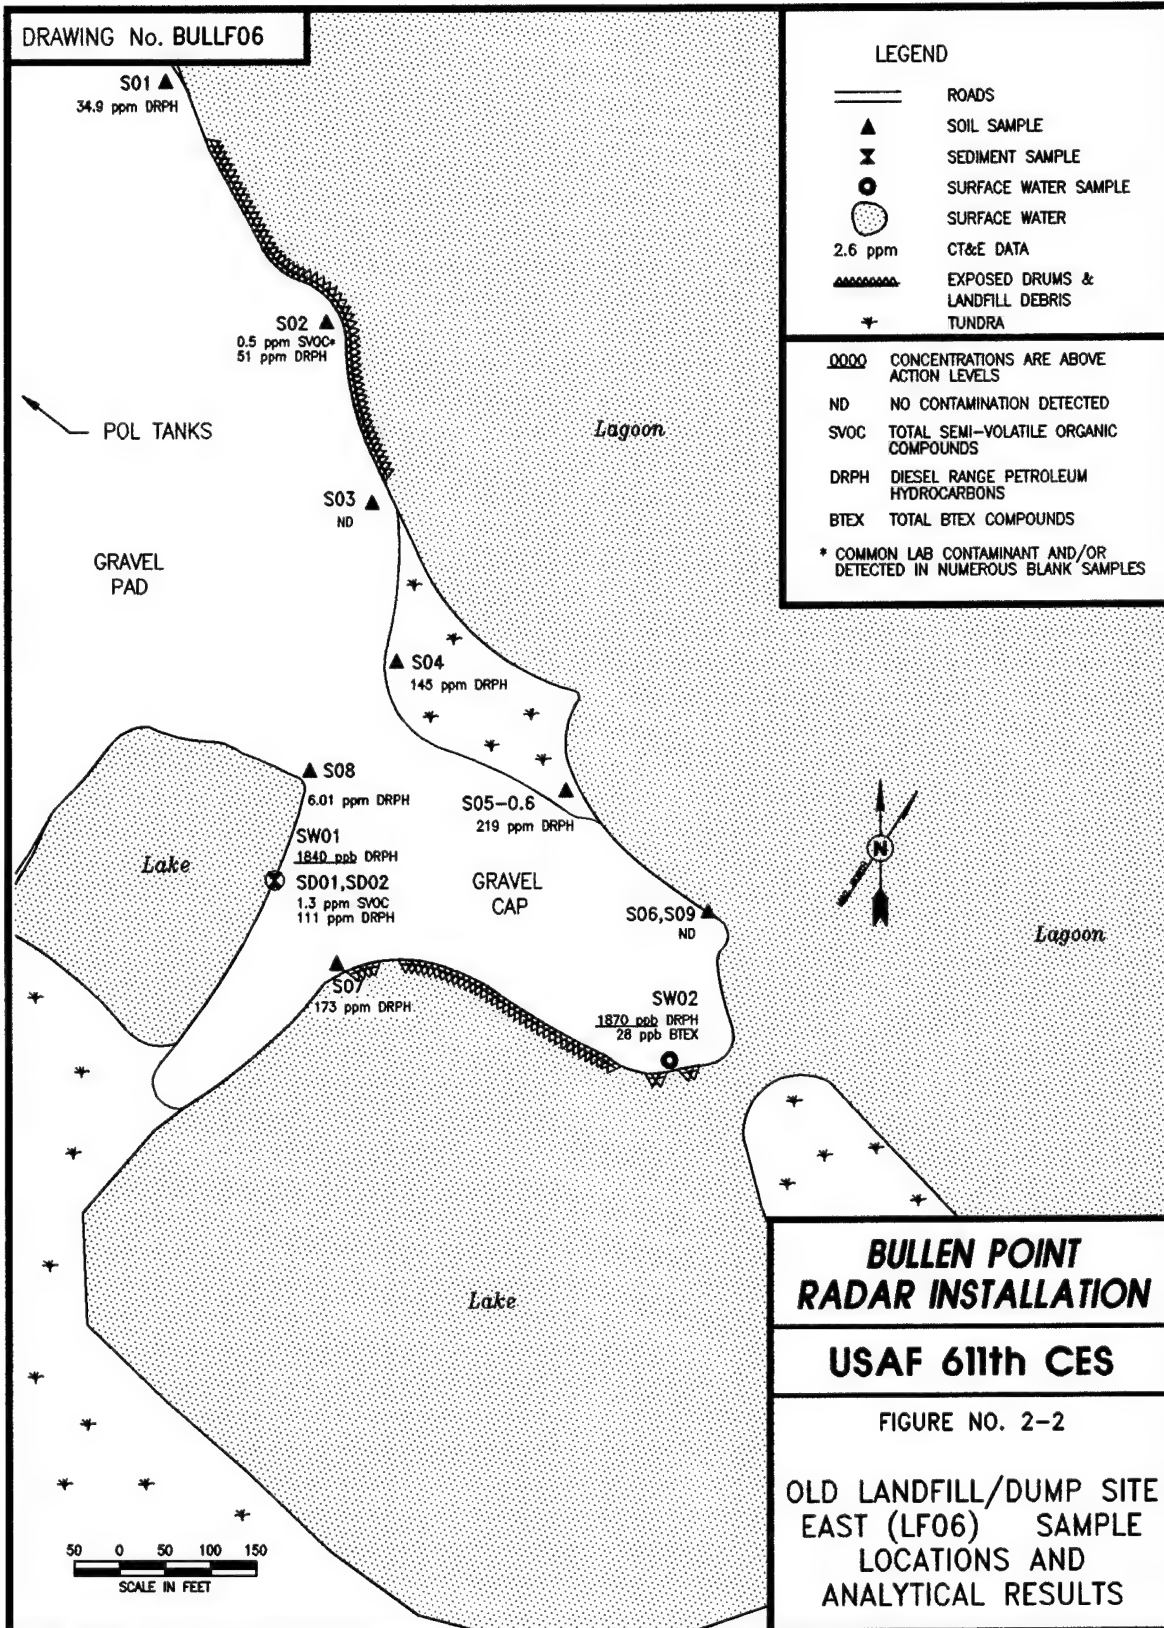
DRAWING No. BULLF06

During the 1993 RI, the Air Force collected nine soil, two sediment, and three surface water samples from the gravel pads, ponds, and tundra areas at the site. Organic compounds detected in soil/sediment samples collected at the site include diesel range petroleum hydrocarbons (DRPH) and two semi-volatile organic compounds (SVOCs). In surface water samples, organic compounds detected at the site include DRPH, and benzene, toluene, ethylbenzene, and xylenes (BTEX).

Metals were not detected above levels of concern in soil/sediment or surface water samples collected at the site. Table 2-2 summarizes the organic chemicals detected above background levels. Sample locations and results are shown in Figure 2-2.

The primary contaminants at the Old Landfill/Dump Site East (LF06) site are relatively low levels of petroleum hydrocarbons (DRPH), BTEX, and other volatile organic compounds (VOCs) commonly associated with diesel fuel. The suspected source of the low levels of petroleum compounds detected during sampling conducted at the Old Landfill/Dump Site East is the POL Tanks (ST05) site. The landfill, which has been inactive since 1971, is downgradient from the

Based on the 1993 RI sampling and analyses, risk assessment, and current and future site uses, remedial actions are not warranted at the site. No significant human health or ecological risks were identified at the site. Therefore, the Old Landfill/Dump Site East (LF06) is recommended for no further action.

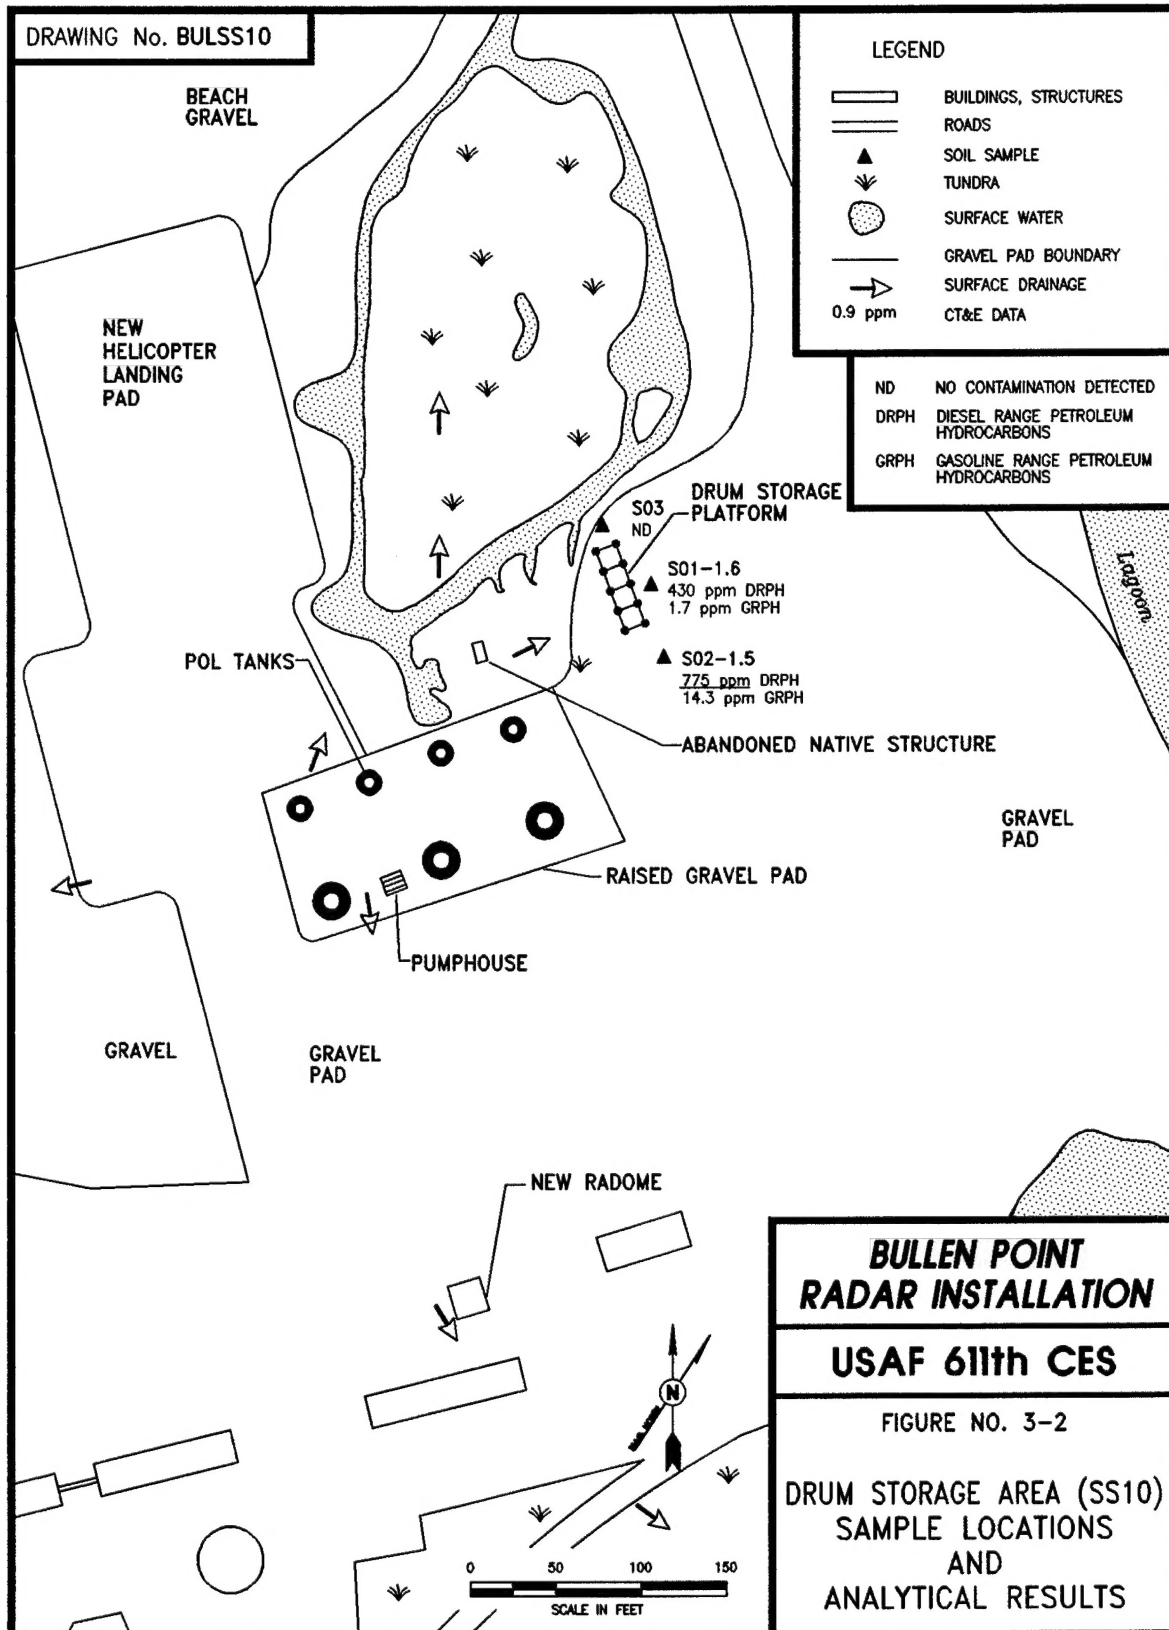
FIGURE NO. 3-2

The Final Bullen Point Risk Assessment (U.S. Air Force 1996b) concluded that risks posed to human and ecological receptors by site contaminants are minimal given current and future site uses. Based on RI sampling and analyses, risk assessments, and current and future site uses, remedial actions are not warranted at this site. No significant human health or ecological risks were identified at the site. Therefore, the Drum Storage Area (SS10) is recommended for no further action.

The selected action and decision for the Drum Storage Area (SS10) is no further action. The action is consistent with the requirements of ADEC, the Air Force, and federal regulations regarding the remediation of hazardous waste sites. This decision is based on the conclusions provided above and the supporting documentation contained in the Final Bullen Point Remedial Investigation/Feasibility Study (U.S. Air Force 1996a) and the Final Bullen Point Risk Assessment (U.S. Air Force 1996b).
